DEVELOPMENT OF A SCHOOL BUS FUEL SYSTEM INTEGRITY COMPLIANCE PROCEDURE

Contract No. DOT-HS-4-00872

April 1975

Final Report

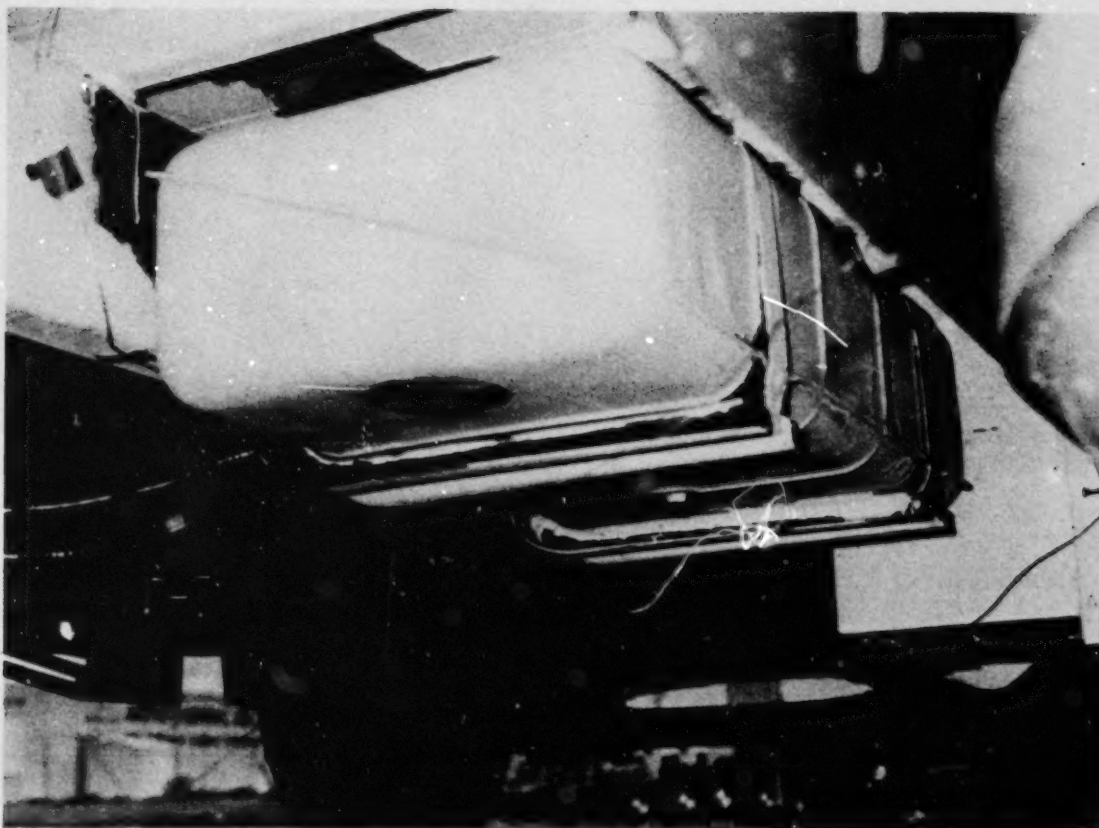
Figure 1. Typical Fuel Tank Installation.

School bus fuel tanks in all side locations are mounted between the body skirt and the longitudinal frame member, as shown in Figure 1. The tank is secured in place by straps that fasten to the frame. Although the tank mounting is fairly secure, the tank has little protection from an impact in this area.

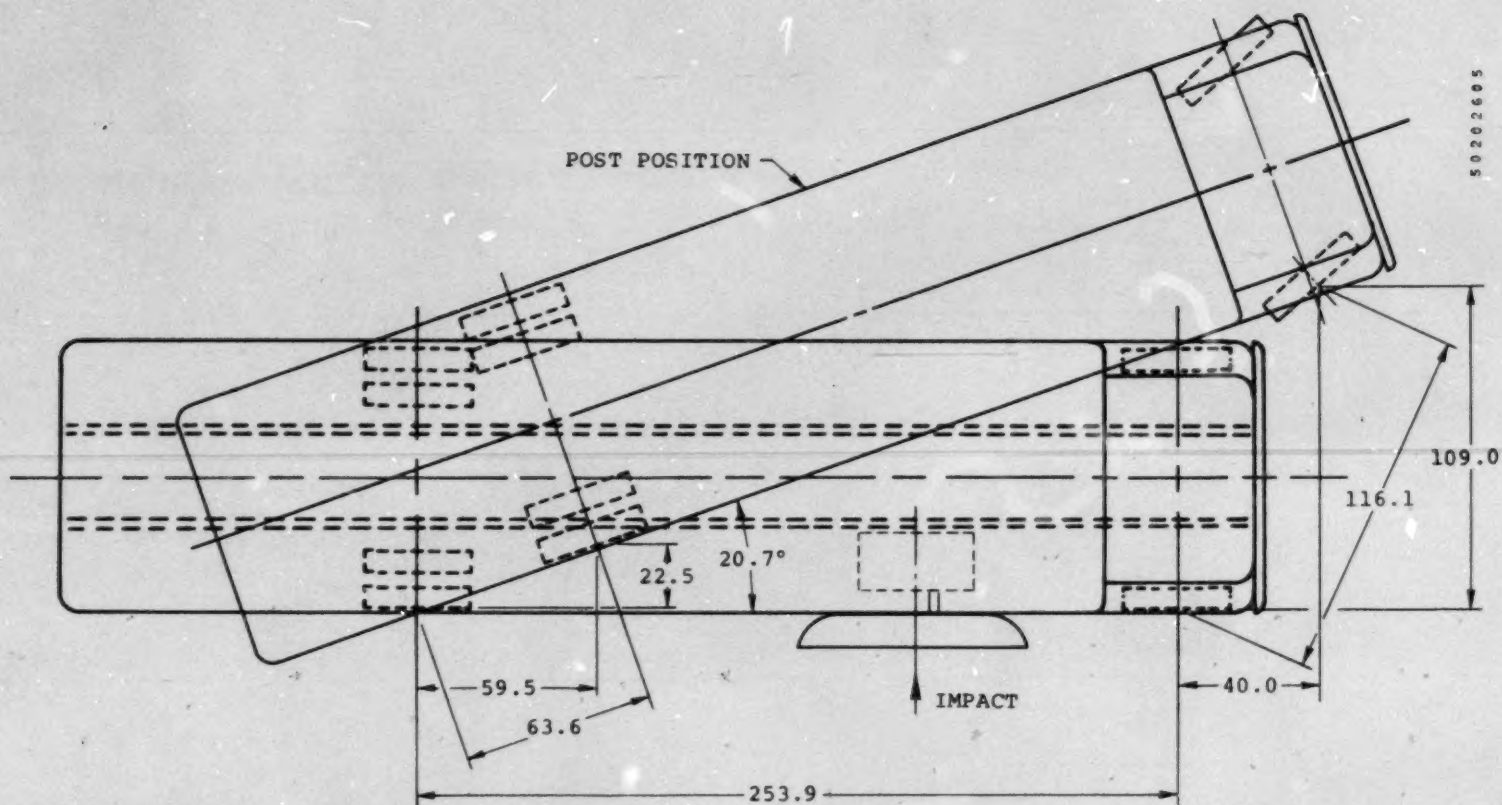
Figure 5. Test 1, Pre- and Post-Test Positions of School Bus.

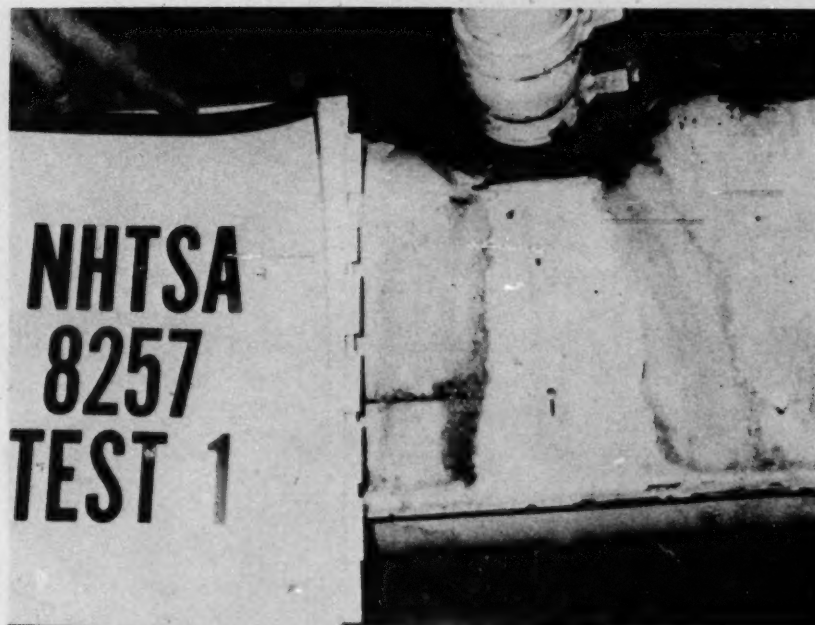
When all of the instrumentation and photographic equipment was ready, the moving barrier was accelerated to a speed of 29.4 ± 0.5 miles per hour. The barrier was released just prior to impact, and impact velocity was 29.38 miles per hour. The barrier impacted the bus and then rebounded straight backward because of the barrier guide shoes. The school bus rotated 20.7 degrees during impact and was pushed sideward several feet as shown in Figure 5. The maximum roll that occurred during the event was 9 degrees. Fuel leakage was immediate, the first timed sample being started as soon as test personnel could get to the leakage. The fuel spillage was measured in four two-minute samples, as listed in Table II. The fuel leakage occurred from an area on the filler spout that was partially separated from the fuel tank. The failure was in the union of the angle fitting of the filler spout to the main tank, as shown in Figures 6 and 7.

Figure 6. Test 1, Filler Spout Failure, Close-up View

Figure 7. Test 1, Filler Spout Failure, Overall View.

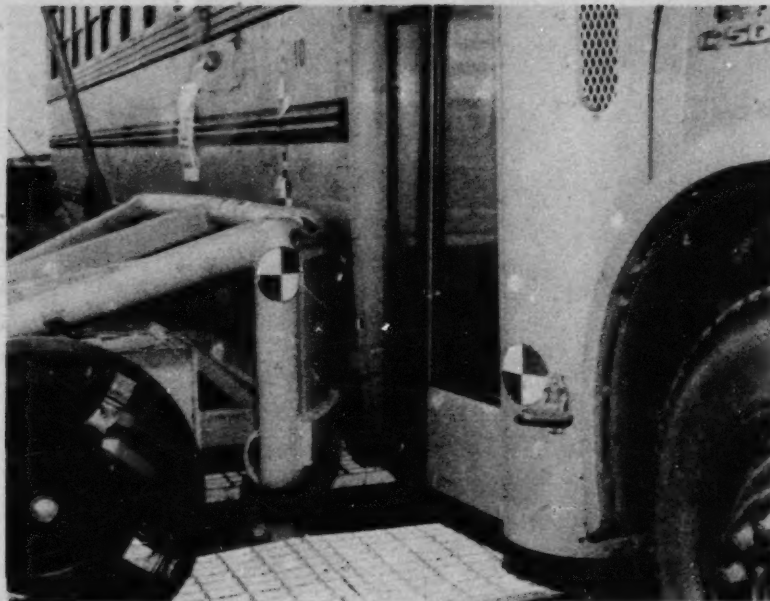
Figure 15. Test 1, School Bus and Barrier Interface, Close-up View.

The impact of the moving barrier was primarily resolved by the floor support structure as shown by the high acceleration levels on the floor and the lateral shift of the floor structure inside the bus. The alignment of the moving barrier to the

school bus is shown in Figures 15, 16, and 17. The lateral shift of the floor structure is shown in Figure 18 and the exterior impact is shown in Figure 19. Penetration of the moving barrier in relation to the fuel tank is shown in Figure 20.

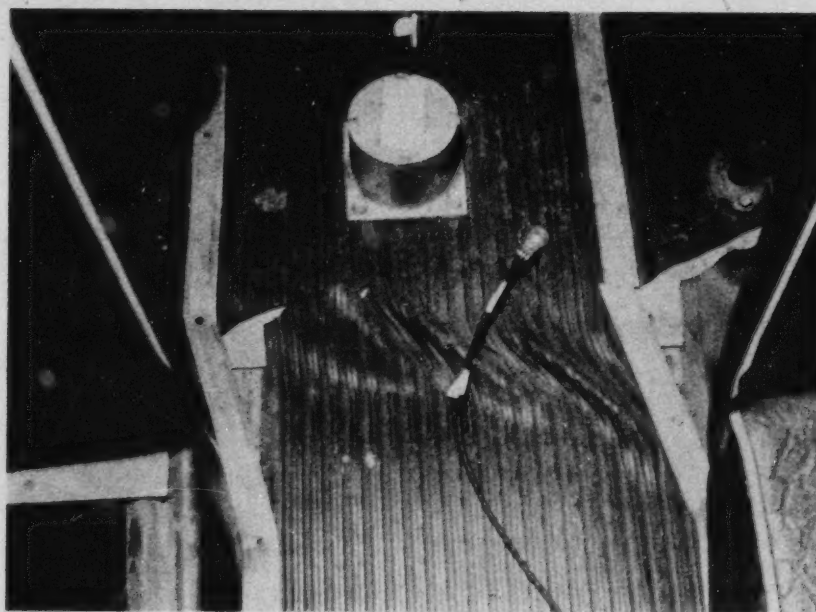
Figure 18. Test 1, Lateral Shift of Floor Structure.

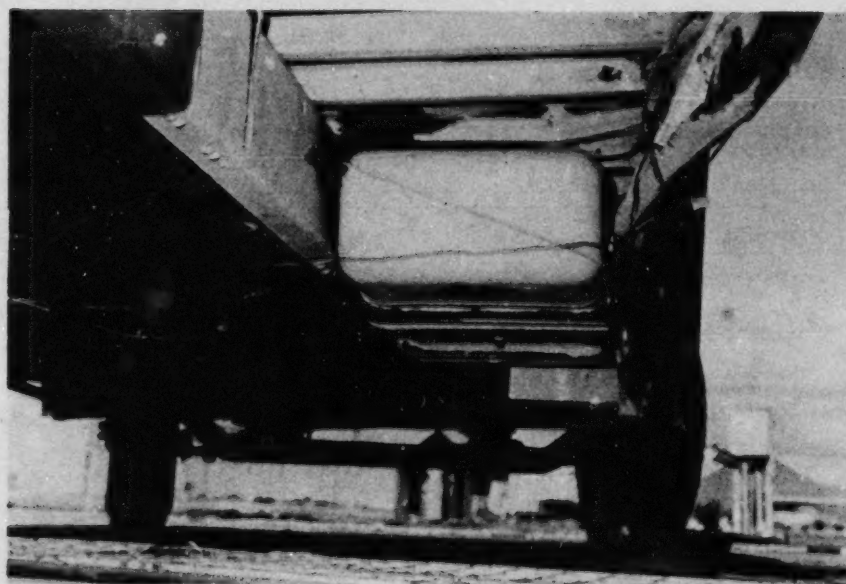
Figure 20. Test 1, Barrier Penetration of Fuel Tank Area.

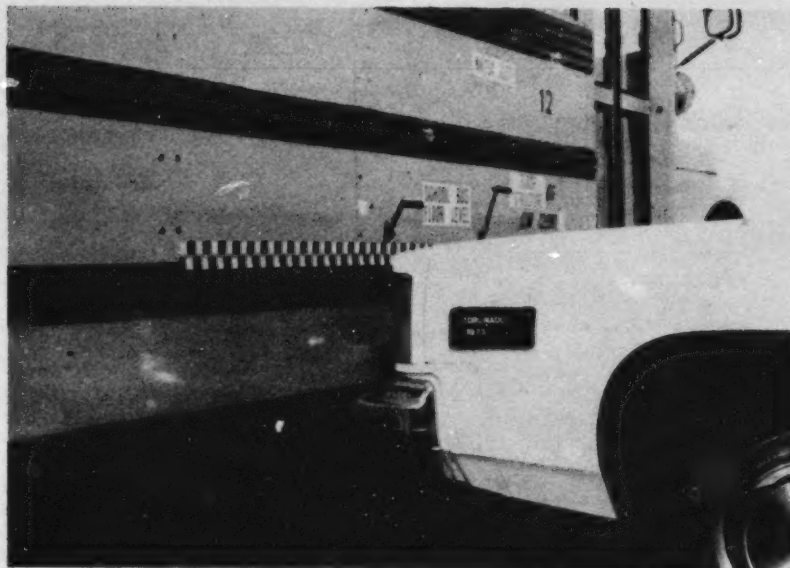
Figure 21. Car/School Bus Interface.

2. An evaluation of Test 1 indicates that the majority of the impact energy from the moving barrier was resolved through the floor of the school bus. A brief survey of 1975 automobiles indicated that the hood would probably pass under the floor and the floor structure during an accident. Figures 21, 22, 23, and 24 show the relationship of the school bus floor and floor structure to the various automobiles. This relationship is also indicated in Accident Report NTSB-HAR-72-2 where a 1961 Chevrolet Impala sedan impacted the side of the school bus and passed under the floor, rupturing and dislodging the fuel tank from the school bus with a resulting fire. The barrier impact for the second test could be made more representative of the vehicle interface by using a lower contoured moving barrier that would represent the height of the substantial structure of an automobile's front end.

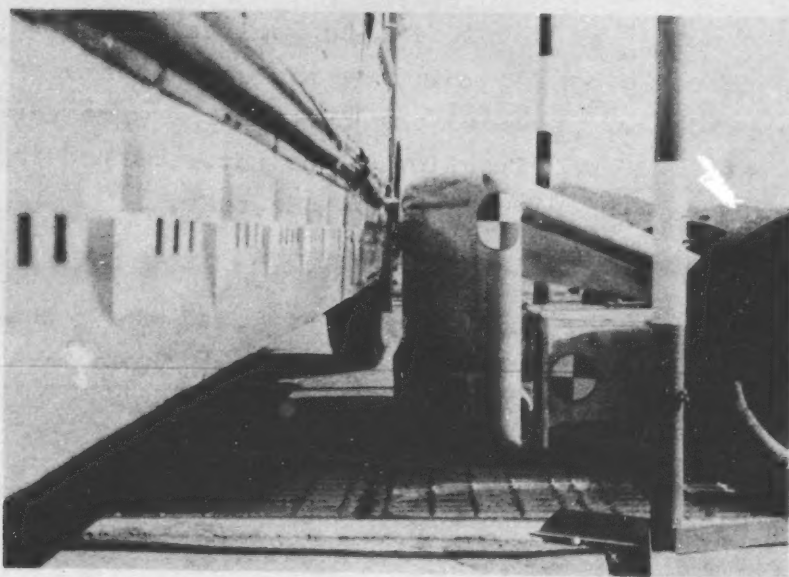
Figure 25. School Bus/Barrier Interface.

1. 29.4 $\pm$ 0.5 mile-per-hour impact speed.
2. School bus ballasted to two-thirds of its gross vehicle weight. The school bus was an identical model to that used in the first test.
3. Side impact on bus by modified SAE J972A barrier.
4. Impact centered on the centerline of the fuel tank.
5. Impact normal to the longitudinal axis of the school bus. Alignment of the vehicles is shown in Figures 25 and 26.

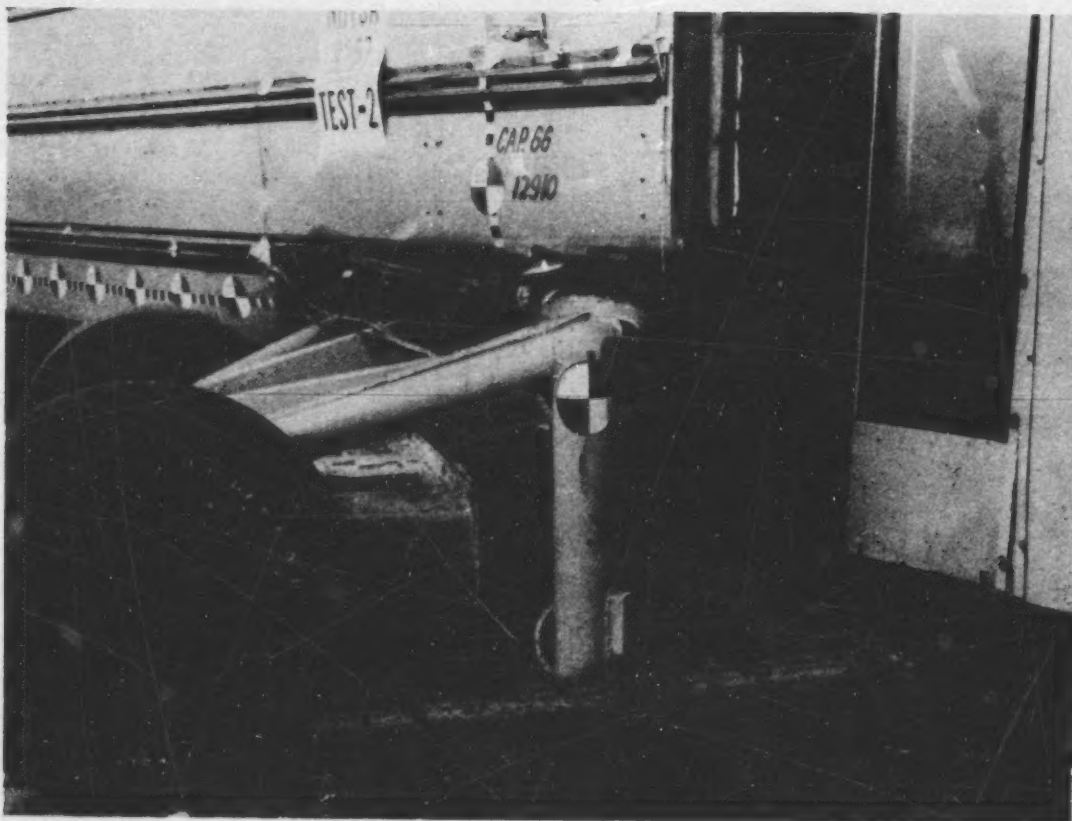
Figure 28. Barrier Penetration of Fuel Tank Area.

The greater damage that occurred during the second test was primarily a result of the modified moving barrier passing under the floor structure as an automobile would, thus inflicting greater local damage to the fuel tank area.

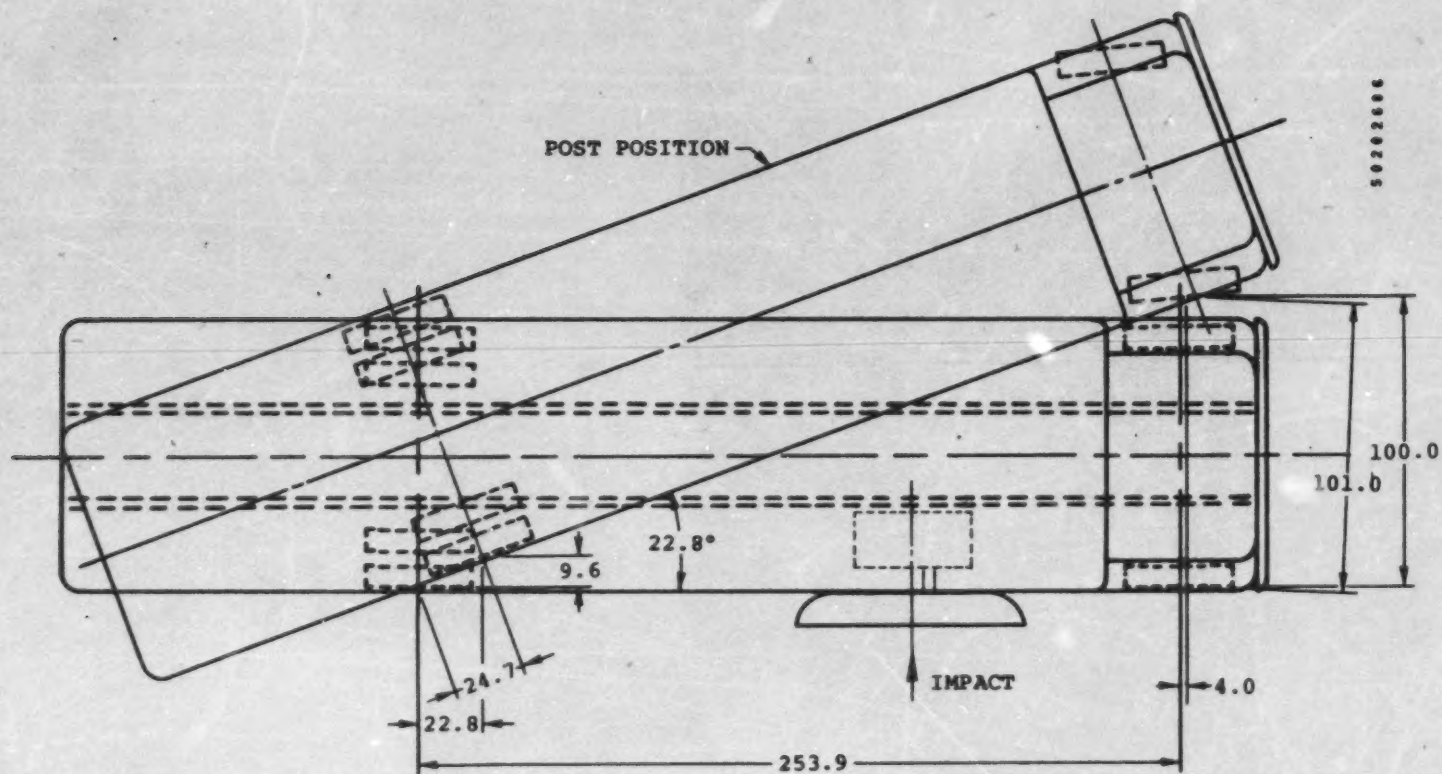
The post-test static crush measured 15 inches at the rear post of the service door and 20 inches at the aft end of the fuel tank. The skirt of the school bus was folded up just below the bus floor level (32.5 inches from the ground). The dynamic crush that occurred during the impact measured 17.9 inches at the rear

Figure 29. Test 2, Pre- and Post-Test Positions of School Bus.

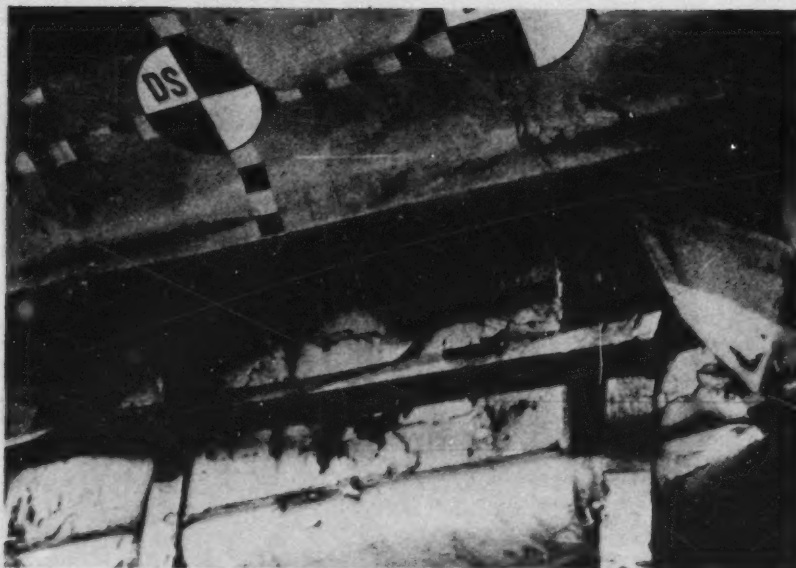
Post-test examination indicated that the tank filler spout had been torn back on the tank and both ends of the tank were split open. The tank had a hole near the bottom in the side facing the barrier intrusion, apparently caused by part of the internal structure of the tank. This hole permitted the tank to completely drain. The fuel tank damage is shown in Figures 30, 31, and 32.

Figure 30. Test 2, Fuel Tank Damage, Close-up View.

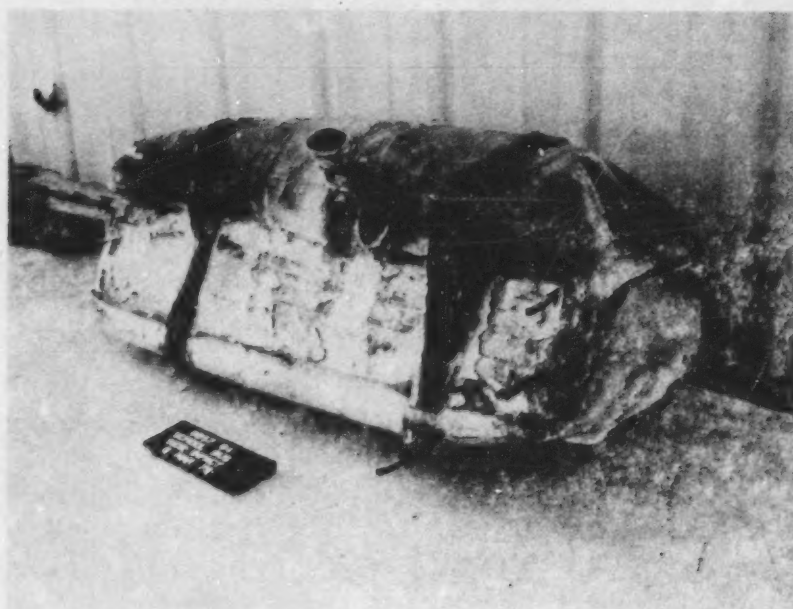
Figure 31. Test 2, Fuel Tank Damage, Overall View.
